Ultrasonic Guided Wave Technology for Non-Invasive
Assessment of Corrosion-Induced Damage in Piping for Pollution
Prevention in DoD Fuel Storage Facilities

ESTCP Project WP-200819

AUGUST 2011

John M. Liu
Carrie E. Davis
Naval Surface Warfare Center Carderock Div.

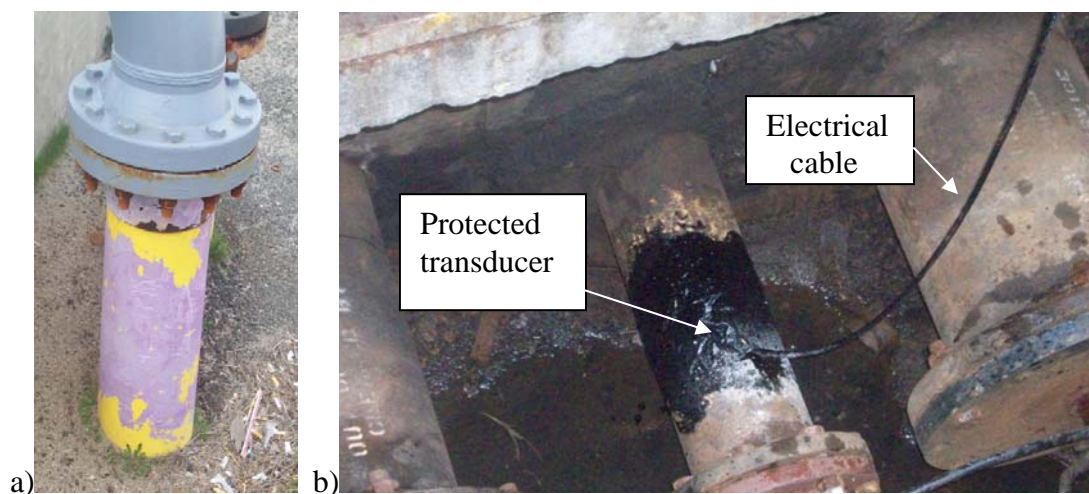
Figure 14. Surface conditions of tested pipe.

14a) Protective paint on a section of pipe to be removed prior to transducer mounting.

14b) Protective tar coating and lead wires for a transducer in the underground pipeline.

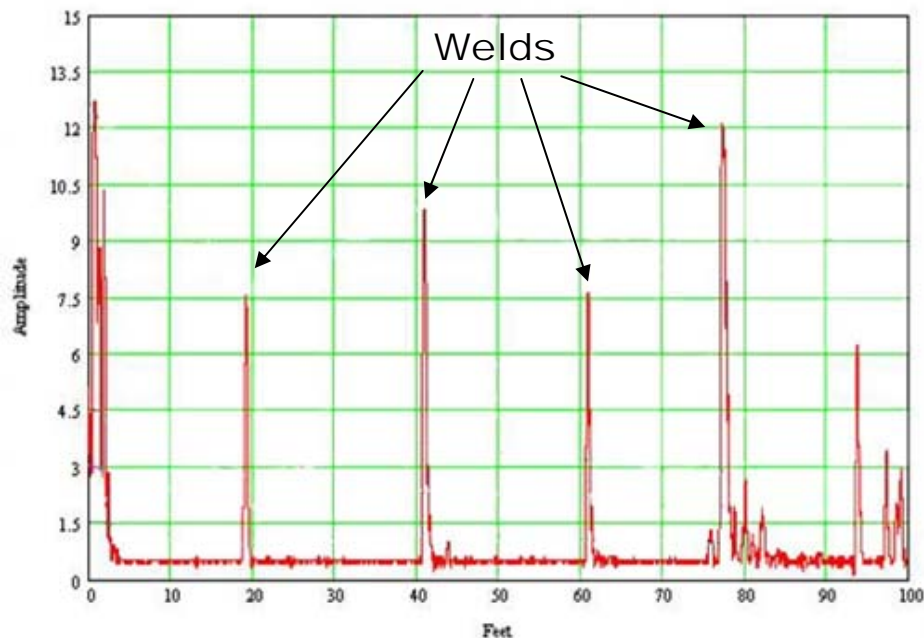
Figure 17. Example of plotted ultrasonic guided wave baseline data for the above-ground coating system pipeline at NSWCCD before corrosion was initiated. The plot shows peaks originating from welds, approximately 20 feet apart, as sensed by a transducer mounted in location 2.

An example of ultrasonic guided wave data showing peak height versus distance along the pipeline (see Figure 8) is shown in Figure 17. Wave propagation speed has been utilized to convert time of flight information to distance information along the pipe. In this figure, the large peaks are reflections from the welds. We note the existence of some small signal peaks with unknown origin before the initiation of corrosion that are not associated with welds. They could be caused by pipe stands, as-manufactured material anomalies, or other unknown conditions. We will come back to these points later in this report.

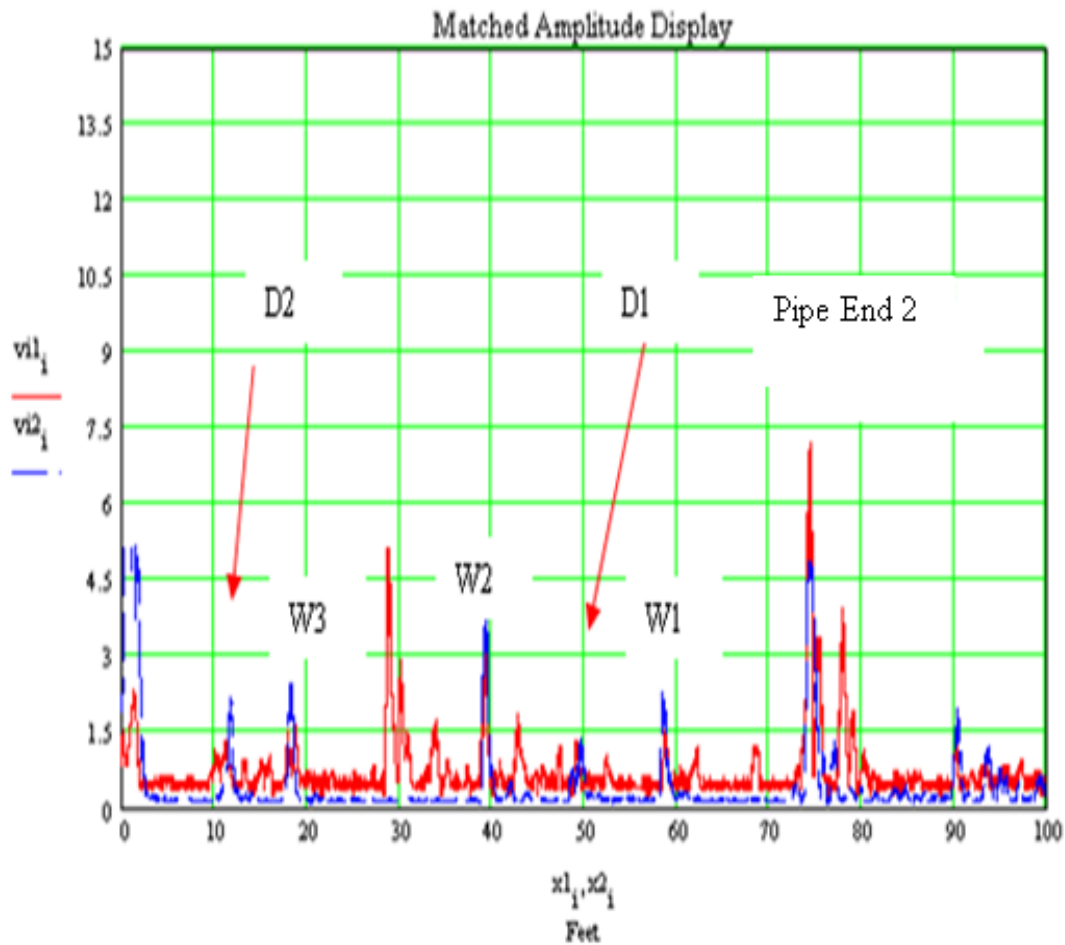
Figure 20. An example of data obtained by dual sensors generating waves propagating towards Pipe End #2 shown in Figure 8.

Shown in Figure 20 is an example of Defects 1 and 2, sensed by two sensors located in locations 1 and 2 separated by an elbow, with wave propagation in the same direction as used shown in Figure 18. The origins of the traces are shifted to match the peaks from the defects. We note that the presence of an elbow increased the noise level, but remained less than 0.2 of the weld signal height at 50 to 80 feet.

The red trace is from the transducer at location 1 and the blue trace is from the transducer at location 2. The origin of the trace for the sensor at location 1 is shifted to account for the sensor separation. The red arrows indicate the locations of Defects 1 & 2. The other matching peaks are from the welds in the pipeline. The large signal at ~30 feet originated from the reflection of the unwanted wave propagating from the transducer at location 1 in the reverse direction towards Pipe End #1.

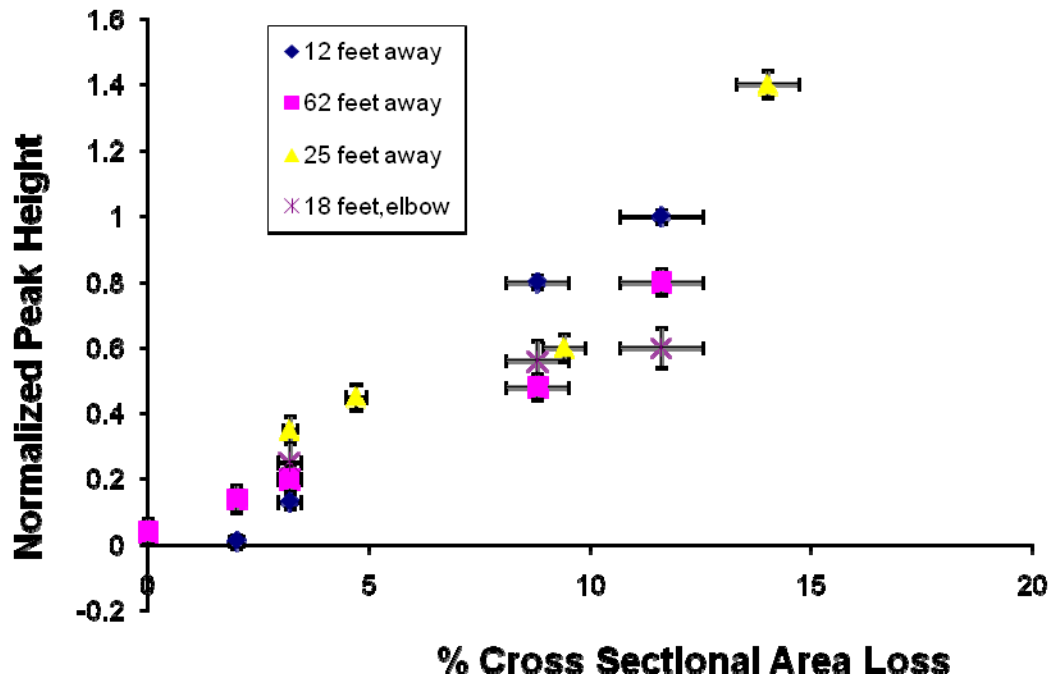
Figure 22. Ultrasonic guided wave signal peak height (relative to a weld signal) plotted against CSAL.

In the following paragraphs, the findings from Phase I are briefly summarized. More details and discussions can be found in a recent publication [4]. A representative data set obtained in the tests performed on the pipeline, shown in Figure 8, is shown in Figure 22. We will discuss the source of measurement errors and statistics. The data summarizes the results for two different

defects varying from approximately 3 inch x 3 inch to 12 inch x 14 inch in surface area, and from 10% to 50% in loss of wall thickness. The signal returned from these two defects was sensed by 3 different transducers, mounted at 3 different distances. The blue symbols represent the signals for a defect (3 inch x 3 inch in area) measured by transducer #2, mounted at 12 feet away from the defect. The pink symbols represent the signals for the same defect measured by transducer #3, mounted 62 feet away, with the wave propagating through several welds before reaching the defect in the opposite direction. The yellow symbols represent the signal for the larger defect (12 inch x 14 inch in area) measured by transducer #3, mounted 25 feet away. The purple symbols represent signals for the same defect measured by transducer #1, mounted 18 feet away with the wave propagating through a 90-degree elbow in the same direction as the wave propagating from transducer #2. Several observations can be made from this plot.

The signal peak height for a defect is influenced by (1) the distance between the defect and the transducer, (2) the number of welds crossed by the propagating waves, (3) the existence of elbows, (4) the asymmetry of a weld or a defect looking from opposite directions, and (5) the size of the defect. As a result of these uncontrollable factors, the peak height values for a defect of 12% CSAL, for example, could range from 0.6 to 1.0 volt, as shown in Figure 22. The same set of data showed that the range of peak heights for a defect of 9% CSAL was approximately 0.5 to 0.8 volt and for a defect of 3% CSAL, the range was 0.12 to 0.35 volt. These variations represent the range of uncertainties for sizing a defect on an absolute basis as a result of the effects of the uncontrolled variables mentioned above. The datum for a defect with 5% CSAL resulted in a signal peak height of approximately 0.4 volts.

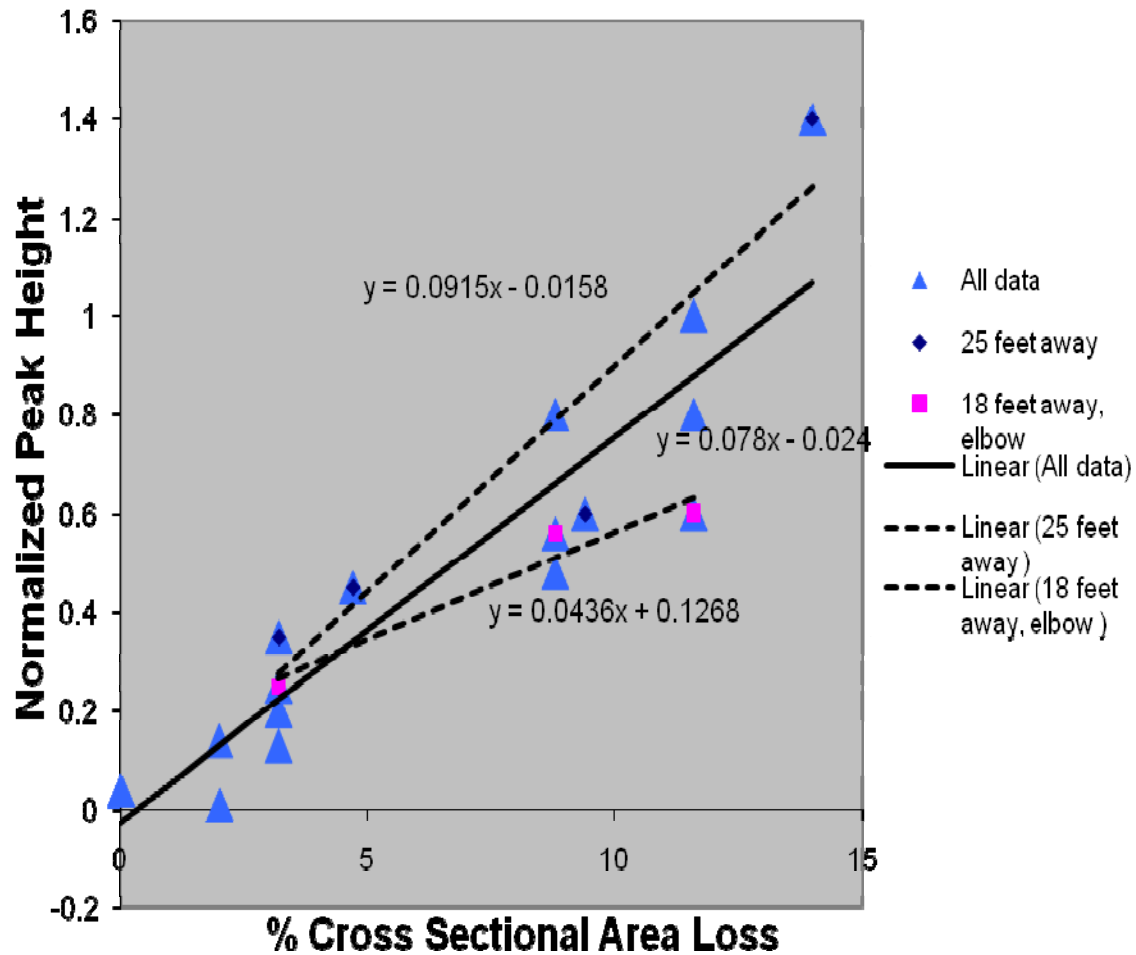
Figure 24. Trend lines for the increase in signal height as the CSAL increases for data obtained in Phase I.

Three trend lines are shown in Figure 24. The solid line is based on the data shown in Figure 22. It represents an averaged trend that provides an empirical “calibration” curve converting relative signal peak height to percentage CSAL for defects. The other two trend lines (dotted) were generated using the two subsets of data including the effects of an elbow (labeled “18 feet away” in the legend) and the ones representing the largest defects (labeled “25 feet away” in the legend). These two dotted trend lines provide the upper and lower bounds for the slope of the average trend line. Defects with 5% and 10% CSAL produced signal peak height of 0.35 and 0.65 volts, respectively, on the average trend line with uncertainties of approximately 25%. These uncertainties are the results of combining all the data obtained from different transducers, located at distances from 12 to 62 feet from the defect, the existence of a variable number of welds and an elbow, as well as defects of different area, volume, and shape.

If we focus our attention on the signals associated with a single transducer, as would be appropriate if we are only interested in measuring the changes of the system from a baseline condition, we realize that the slope of the trend line is mainly controlled by the variations of electronic noise and defect shape change over time. The details of the wave propagation across welds and elbows, as well as, scattering mechanisms affecting the absolute signal peak heights are less important when only signal changes are considered, since the effects of these variables (except for the size of the defect) are constant as a function of time. As shown in Figure 23, the uncertainties associated with electronic noise and defect shape were represented by the vertical (approximately 0.1 volt) and horizontal (less than 2% CSAL) error bar at each datum. For the purpose of tracking defect growth, we observed in Figure 24 that the slope of the average trend line departs from those represented by the two extremes by no more or less than a factor of 2. Additional discussions of the Phase I results can be found in a recently published paper [4].

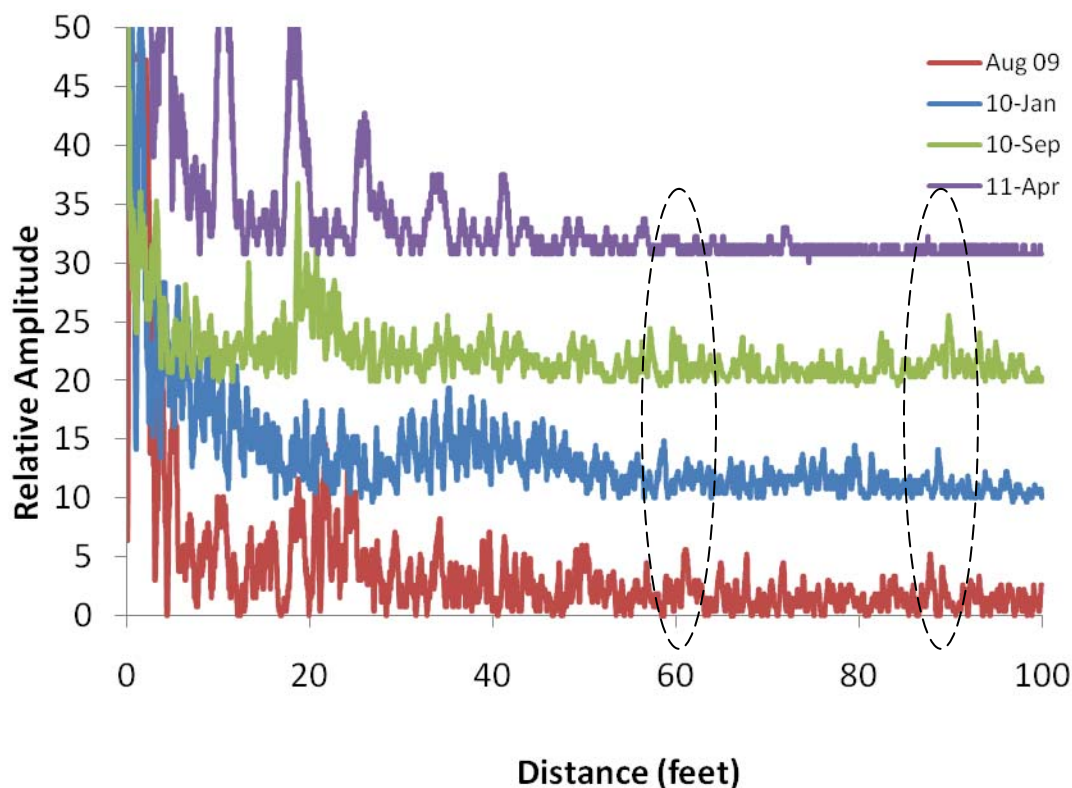
Figure 28. Monitoring changes in data sets obtained at the baseline and successive months by underground sensor #22532.

In Figure 28, the data traces collected by an underground sensor (#22532) from the baseline in August 2009 through January 2010, September 2010, and April 2011 are stacked up (with an offset of 10 units on the vertical axis) to facilitate a comparison of the stability in the peaks detected throughout the course of this project. In particular, the pair of peaks around 90 feet pointed at in Figure 25 appeared to be consistently located to within ± 2 feet over the course of 20 months of monitoring. A group of peaks around 60-62 feet appear to be consistently present also.

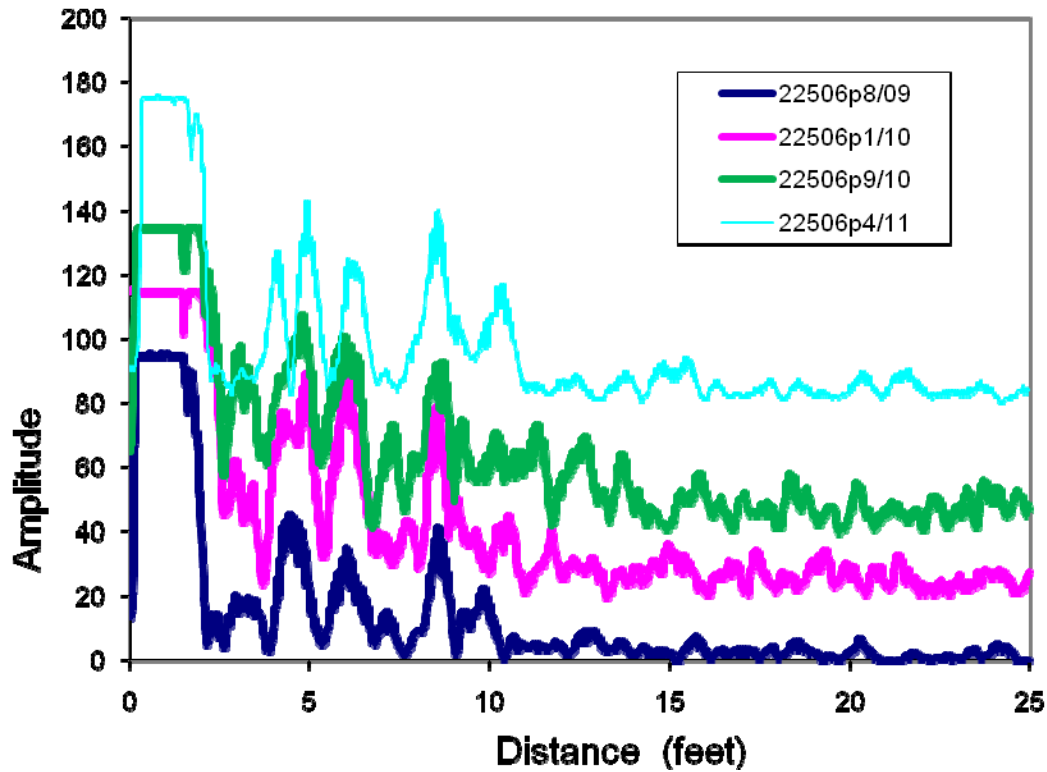
Figure 29. Monitoring changes in data sets obtained by above-ground sensor #22506 at the baseline and successive months at VP5.

In Figure 29, we stack up (with an off-set of 20 units along the vertical axis) the traces obtained from above-ground sensor #22506 over successive monitoring intervals starting with the baseline trace (blue) in August 2009 at the bottom and ending with the April 2011 trace (light blue) at the top. Because of the existence of two or more 90 degree bents in this section of the pipeline between VP 5 and VP 20, identifiable by the pairs of peaks between the origin and 15 feet on the x- axis, the signal to noise ratio rapidly decreased beyond 20-25 feet. It appeared that the stability of the peaks in this section of the pipeline was limited to 15 feet or less over the course of the 20 months of monitoring period.

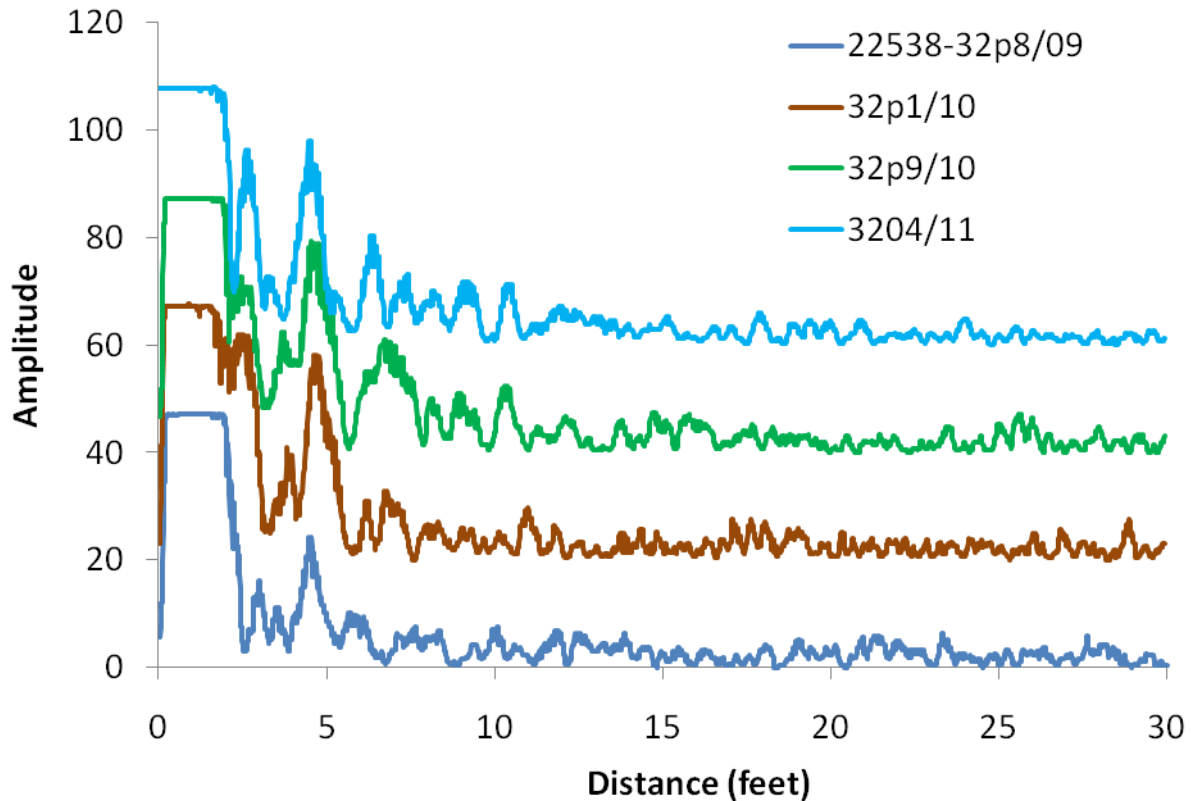
Figure 30. Monitoring changes in data sets obtained by above-ground sensor #22538 at Chambers Field over a period of 20 months.
An offset of twenty units along the vertical axis has been added to each successive trace before plotting.

In Figure 30, the traces obtained by above-ground sensor #22538 over the 4 monitoring periods (August 2009 in dark blue, January 2010 in red, September 2010 in green, and April 2011 in light blue) are stacked up (with a vertical off-set of 20 units) to facilitate a comparison. It appeared that the existence of 90 degree elbows again reduced the signal to noise ratio, so that the reproducibility of peak locations was limited to approximately 15-20 feet. The lack of detailed mechanical drawing did not allow a definitive identification for the structural components giving rise to these peaks.

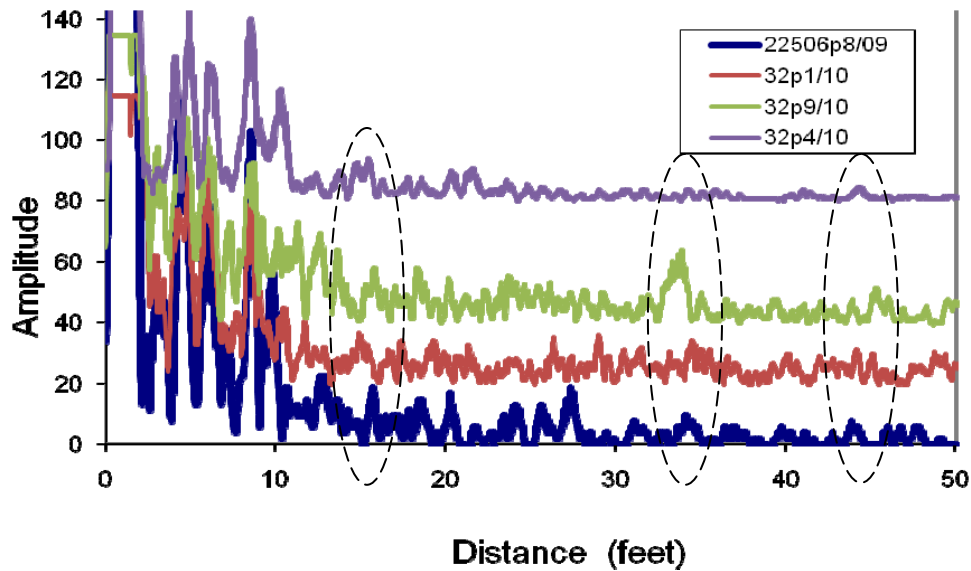
Data traces in Figure 32 are for waves propagating from VP 5 towards VP 20 from sensor #22506. Focusing on the groups of peaks around 16 feet, 35 feet, and 44 feet, we observe that the normalized peak heights at some locations (e.g. 35 feet) have not been increasing consistently or they remained relatively unchanged over the course of the monitoring effort. The locations where peak heights remained constant most likely originated from static structural features such as welds. Inconsistent changes in peak heights could be due to signal noise and/or multiple reflections unrelated to defects.

Figure 32. Monitoring signal changes in data sets obtained by above-ground sensor #22506. An offset of twenty units along the vertical axis has been added to each successive trace before plotting.

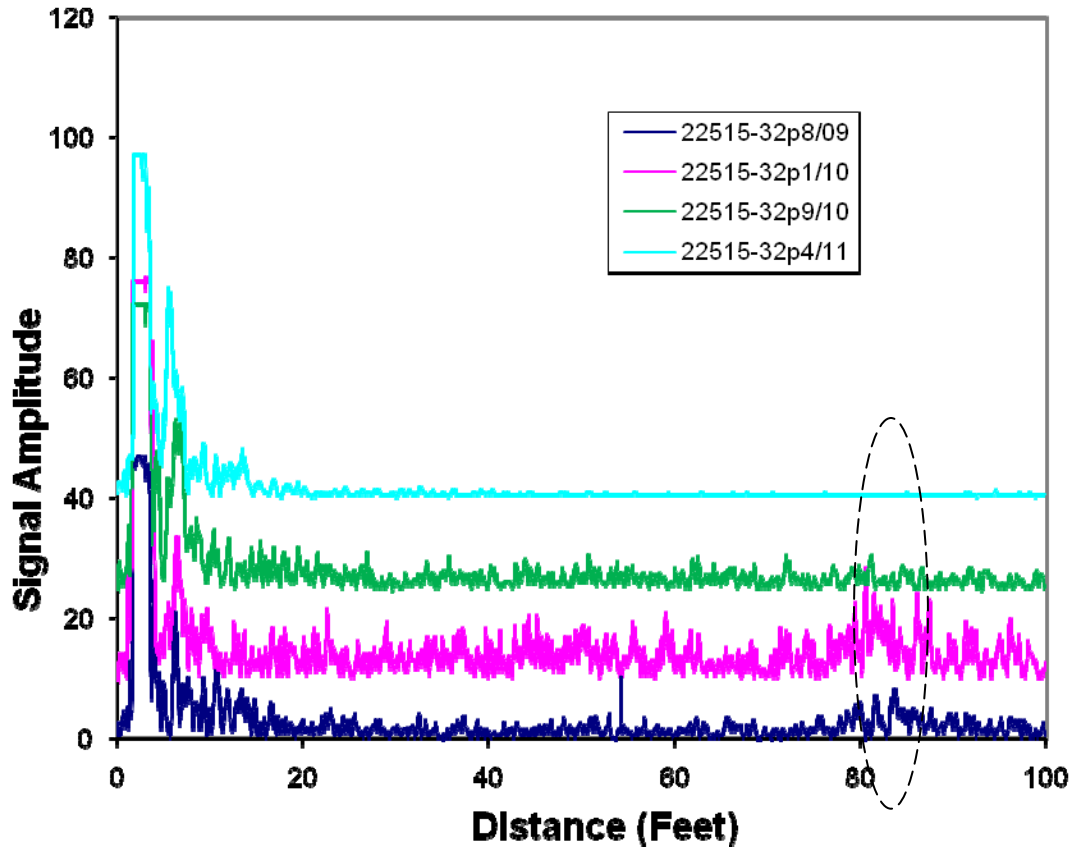
In Figure 33, the inconsistent increases in peak heights obtained by the above-ground sensor #22515 at long distance are also shown. The peak at 82 feet has not yet increased in height consistently over the course of this monitoring effort, and cannot yet be identified as an indication of defect growth at that location without additional monitoring. We also note that the overall signal strength beyond 40 feet in the trace obtained in April 2011 was much reduced from those observed in earlier traces, probably due to a deterioration in the stability of the transducer over time.

Figure 33. Monitoring changes in data sets obtained by above-ground sensor #22515.
An offset of ten units along the vertical axis has been added to each successive trace before plotting.

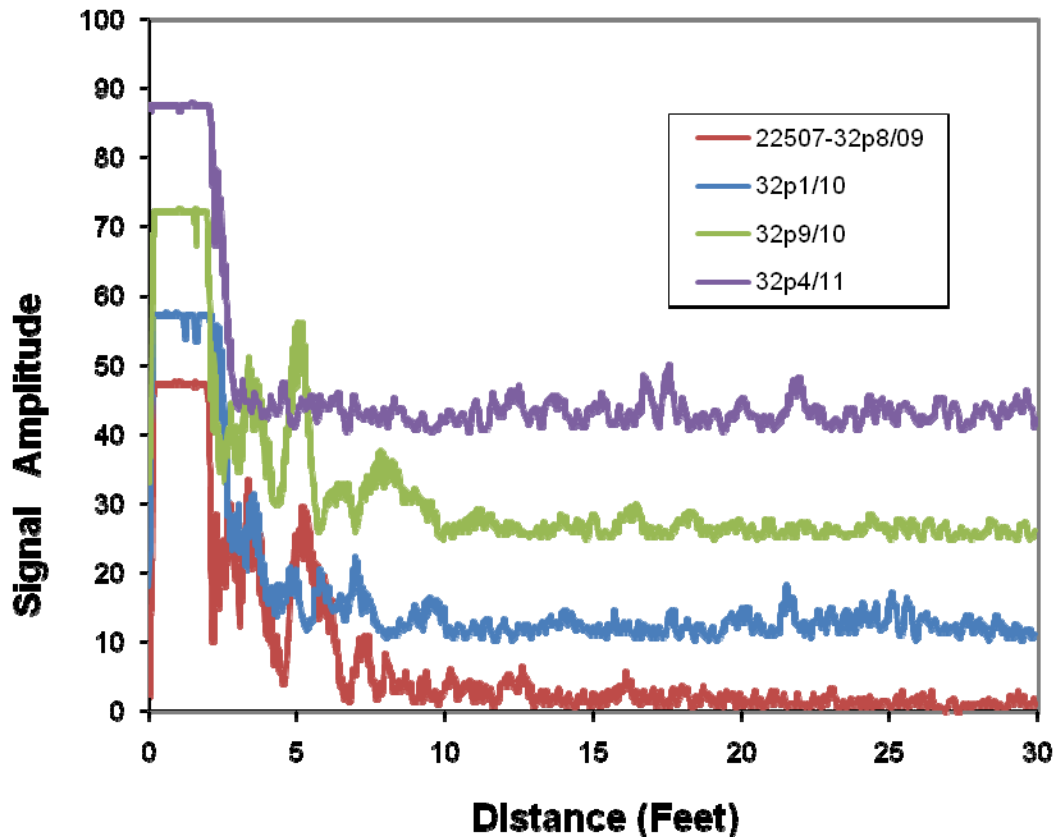
Figure 34. Monitoring changes in data sets obtained by sensor #22507.

In Figure 34, we stack up traces (August 2009 in red, January 2010 in blue, September 2010 in green, and April 2011 in purple) obtained by a sensor #22507 propagating waves from VP 5 towards the water front, over the period of 20 months. The amplitude consistency of the traces was not good. Even though the signal to noise ratio appeared to be good in the April 2011 trace, the matching of peaks over the 4 monitoring periods was not consistent from one period to another. The group of peaks around 20-25 feet should be monitored for additional time before its origin can be identified.

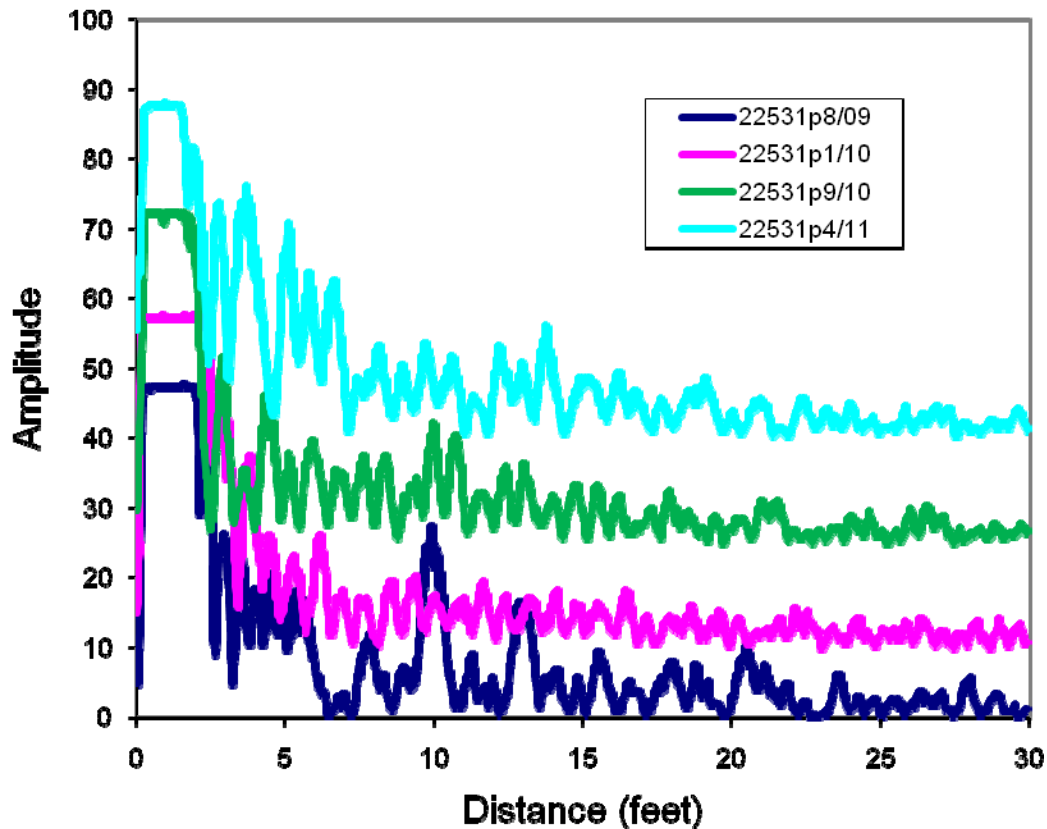
Figure 37. Changes in data sets obtained by under-ground sensor #22531 inside BL 20. An offset of fifteen units along the vertical axis has been added to each successive trace before plotting.

Figure 37 is an example of peak splitting over the course of the monitoring months. The peaks at 10 and 13 feet appeared to split in later months. Our work in Phase I suggested that such splitting was associated with corrosion around a weld. However, there is not yet consistent peak height increase in these split features. Additional monitoring is required to further identify the nature of these signals.

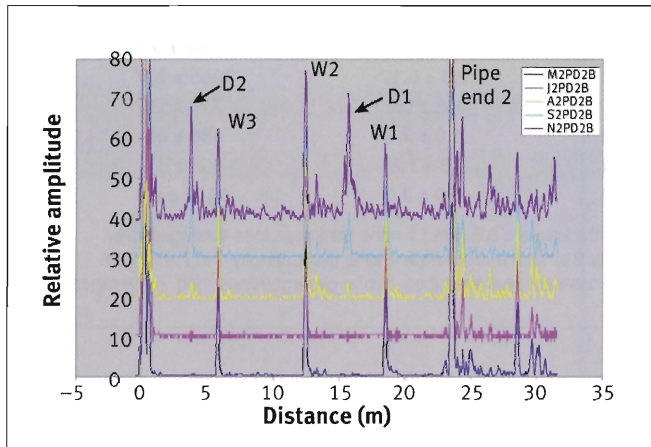
Figure 2. Systematic increases in peak heights for growing D1 and D2 sensed by transducer at Location 2. D1 was located at approximately 15.3 m and D2 was located at approximately 3.7 m. The other large peaks, approximately 6.1 m apart, are from the welds in the pipeline. The baseline signal (May) is blue, the June signal is pink, the August signal is yellow, the September signal is light blue and the November signal is purple. An offset of 10 units along the vertical axis was added to each successive trace before plotting.

Examples of systematic increases in discontinuity peak height as corrosion progressed are shown in Figure 2. Here, traces obtained over the months of May, June, August, September and November were stacked up beginning with the May (baseline) trace shown at the bottom of Figure 2. In order to facilitate the examination of each trace in detail, an offset of 10 units along the vertical axis was added to each successive trace before plotting in Figure 2. The labels for the traces (such as M2PD2B for the month of May), as stated before, indicated that the transducer was at Location 2, propagating guided waves in the positive (P) direction, and the weld signal behind (B) D2 was used to normalize the peak height. It can be seen that the discontinuity signal height depends on the size of the discontinuity, the distance between the transducer and the discontinuity, and the number of welds in the wave propagation path. Note that the weld peaks did not decrease in amplitude following a well-defined exponential decay curve in this welded pipe. As previously mentioned, these measurements of peak height, originated from D2 by the transducer in Location 2, provided the simplest case of discontinuity growth monitoring in a short, straight pipe section without the interference of a weld. In Figure 2, it can be noted that the signal at approximately 13.4 m immediately behind the peak for W2 did not increase systematically throughout the course of the experiment, signifying that it did not originate from a growing corrosion discontinuity.

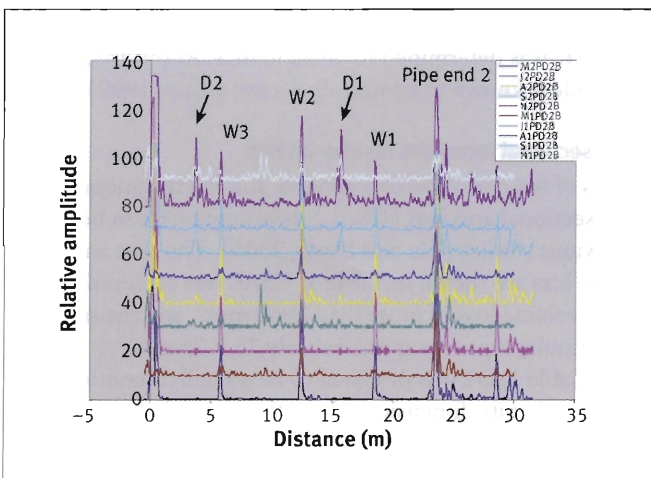
Figure 3. Signal traces for transducers at Locations 2 and 1 (time-shifted), for waves propagating in the same positive direction towards Pipe end 2. The initial portion of the traces for the sensor at Location 1, including the effects of the elbow, was deleted to allow for the matching of peaks in the traces for both sensors. D2 was at 3.7 m and D1 was at 15.5 m. The other matching peaks originated from welds. An offset of 10 units along the vertical axis was added to each successive trace before plotting.

The signals received by the transducer located in Location 1, which was located behind a 90° elbow, were superimposed on the traces displayed in Figure 2 for the same two discontinuities, D2 and D1. The obtained traces are shown in Figure 3. Here, the origin of the traces for the transducer at Location 1 (such as M1PD2B) has been shifted to account for the distance separating the two transducers, in order to match the peaks corresponding to the welds in both sets of traces. Wave propagation was in the same positive direction for both data traces. As in Figure 2, the traces in Figure 3 were stacked upwards starting with the May (baseline) traces measured by the two transducers, followed successively by the June traces for Transducer 2 and Transducer 1, respectively, and then by the traces for the later months.

Figure 3 shows that the peak associated with D2 at 3.66 m was below noise level in the traces obtained by the transducer in Location 1 for the month of June and August, as a result of the adverse effect of the 90° elbow in front of this discontinuity. When D2 reached a CSAL of 8.8% in the month of September (see Table 1), its peak height was above noise level. Similarly, D1 was below noise level until a CSAL of 5%

was reached in the month of August. The spurious signal at approximately 9.1 m originated from the reflection of the unwanted wave propagating from the transducer at Location 1 in the reverse direction towards Pipe end 1.

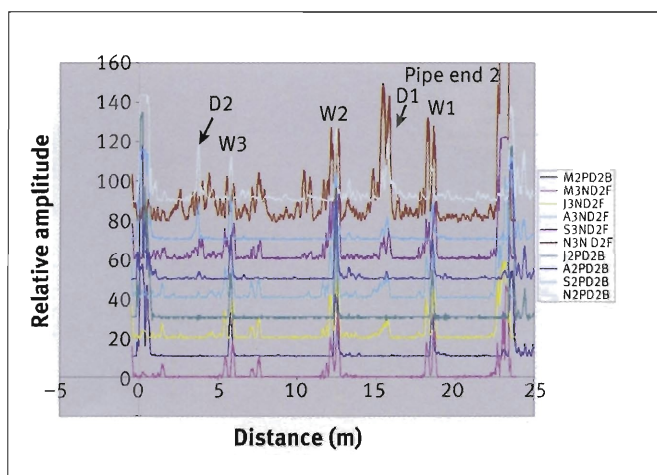
In Figure 4, a comparison is made between the groups of traces obtained by transducers placed in Locations 2 and 3. The origin of the horizontal (distance) axis is defined by the location of the transducer in Location 2. Starting from the bottom, the traces for Transducers 3 and 2 were stacked up alternately, beginning with the May trace for Transducer 3. Because wave propagation was in opposite directions along the pipe, the traces for Transducer 3 are plotted from right to left along the distance axis in order to match the weld peaks. In this way, the peaks originated from D1 and D2 should appear in the same locations (approximately 3.7 and 15.5 m, respectively) among all the traces. The systematic increase in peak heights as corrosion progressed from May (baseline) through November can be seen, except for the trace for the month of June (labeled J3ND2F) obtained by Transducer 3, in which the peak for D2 was below the noise level. This shows that the signal associated with a small discontinuity in the shadow of a large discontinuity was not detectable, as a result of the distortion and energy loss caused by the presence of a large discontinuity in front of it. This distortion also increased the uncertainty in peak height measurements for D2 in the later stages of corrosion, as seen in the November trace labeled N3ND2F. Most of the welds showed a double peak feature in the wave trains detected by the transducer at Location 3. As pointed out earlier, it is believed that these peaks were due to imperfect elimination of the wave propagating in the reverse direction, which was reflected from Pipe end 2, and then superimposed on the main wave train propagating along the negative direction. The signal at 7.6 and 10.7 m, detected by the transducer in Location 3,

Figure 4. Superimposed signal traces obtained by transducers at Locations 3 and 2 with the wave propagating in opposite directions. An offset of 10 units along the vertical axis was added to each successive trace before plotting.

did not systematically increase in amplitude, and was not consistent with the results obtained by the transducer in Location 2. It can be concluded that these were spurious signals unrelated to corrosion.
